A.I.R Pump Removal

This information based on a first generation S-10 with a 2.8L. May be applied to any GM Vehicle with TBI or Isuzu Trooper with 2.8L

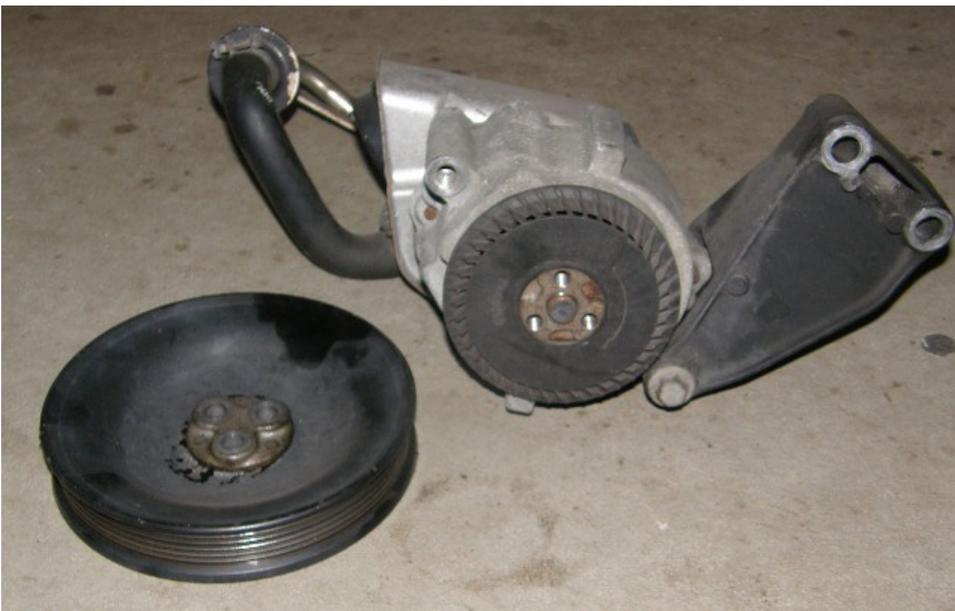
Here is the selection of parts that are removed from the front of the engine. It cleans up a lot of space and leaves a cleaner look when they are gone. If you were to re locate the battery at this point the entire front right corner under the hood would be clear.

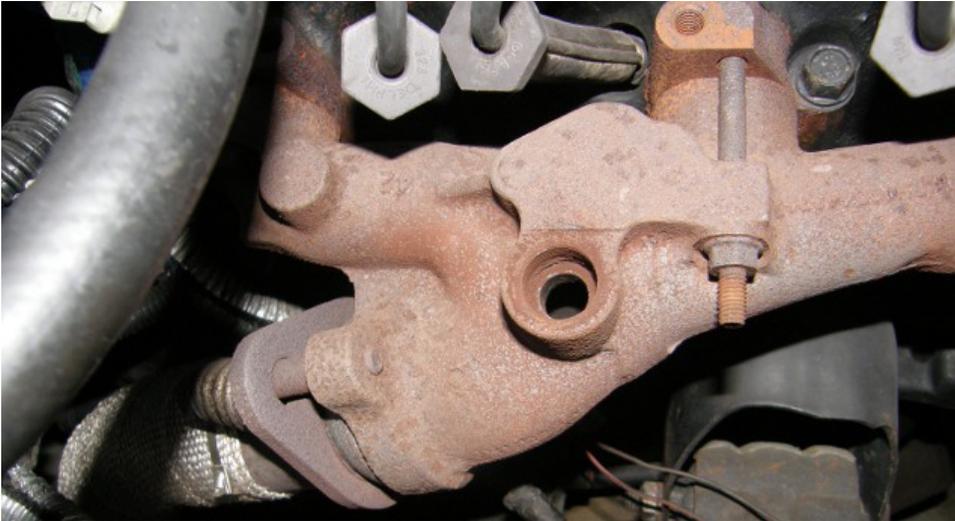
This is the hole in the exhaust that needs to be plugged. The threads are 7/8-18 and can be plugged with an oil pan bolt or a male SAE Inverted Flare Plug.

a breaker bar. This piece will be hard to remove after several years of being subjected to exhaust heat. In most cases and open end wrench won't fit in the confines of an engine compartment so unless you are on an engine stand that option is out. With the fitting out you need to plug the hole. The thread is 7/8-18 which is not very common. It is used on some oil pans and on SAE Inverted Flare nuts. So the easiest thing to find is an oil pan plug from your local parts store. A hydraulic fitting shop may have the flare plug and you could use that. But the oil pan plug will be easier to find in most cases and then all you need is a 7/8" copper or brass washer to make the seal. Once you have these parts simply plug the hole in the exhaust manifold. Other solutions to this problem would be finding the passenger exhaust manifold from an Isuzu Rodeo with a 3.1L which has no A.I.R. system and so the hole in the manifold was never drilled and tapped. Or you could install a set of headers which would obviously eliminate this step.

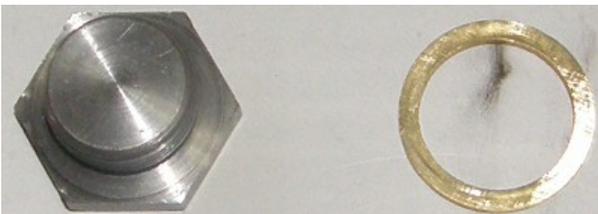
Below: Here is the plug and washer needed to plug the hole in the manifold. They can be purchased at most parts stores.

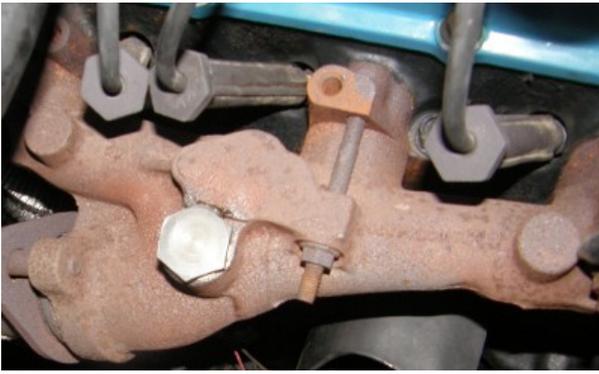
Here is the plug and washer installed into the manifold. Make sure you clean up the rust build up on the surface where the washer seals against. Also if you need a tap to clean the threads it may be easier to tell the parts person you need to repair a 7/8-18 spark plug thread. Snap-On sells one as part number T2818 and it runs around \$25. Just make sure you vacuum out any filings that drop down.

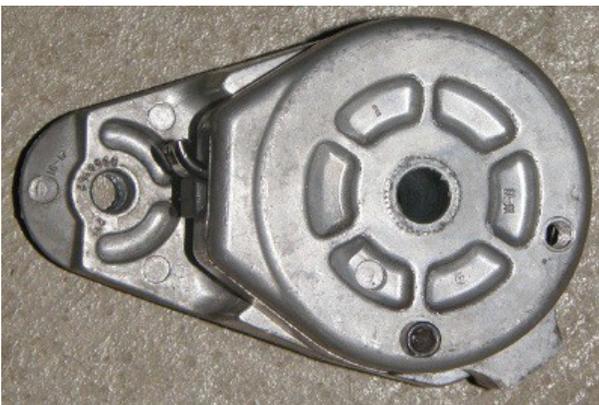
Here is the back of the tensioner. This is an aftermarket replacement for a stock 2.8L. Notice the old pin position at the right. It was relocated by drilling and tapping the aluminum casting. The pin is 90 degrees to the pulley. The pin is a 1/4UNC Allen head cap screw.

Now on to the second problem. Since you have now removed one pulley from the belt system your belt will be much too long. Plus the tensioner is on the wrong angle. Do not try and just order a short belt and use the same tensioner. It does not work you will never find a belt you can actually slip on that will give you enough tension with the stock tensioner. However there are a few good solutions for this problem. One is simply buying GM tensioner 10099984 this tensioner is for an Isuzu Rodeo with a 3.1L V6. You can also drill and tap the stock tensioner and install a 1/4UNC Cap Head bolt which will create a new pin to re locate the tensioner and grind off the old pin. The new pulley will now ride on the other side of the belt and you may want to replace it with a ribbed pulley which is AC Delco part number 38009. When the tensioner is installed correctly order a serpentine belt for a 1991 Isuzu Rodeo, order whether you have A/C or Not and you will get the correct length belt. One other problem will crop up when you try and install the tensioner on a truck without A/C. Gm used a larger water pump pulley (138mm) on vehicles without A/C. This larger pulley will contact the tensioner pulley when installed so you need to create clearance by using a pulley from a truck with A/C (120mm) GM P/N 24503896. This pulley is available on Isuzu trucks with a 2.8L or 3.1L with A/C or any S-Truck with a 2.8L with A/C. If you have swapped in a 3.4L from a Camaro and kept the Camaro pump or if you have installed a Camaro water pump into your truck you will already have the right sized pulley.

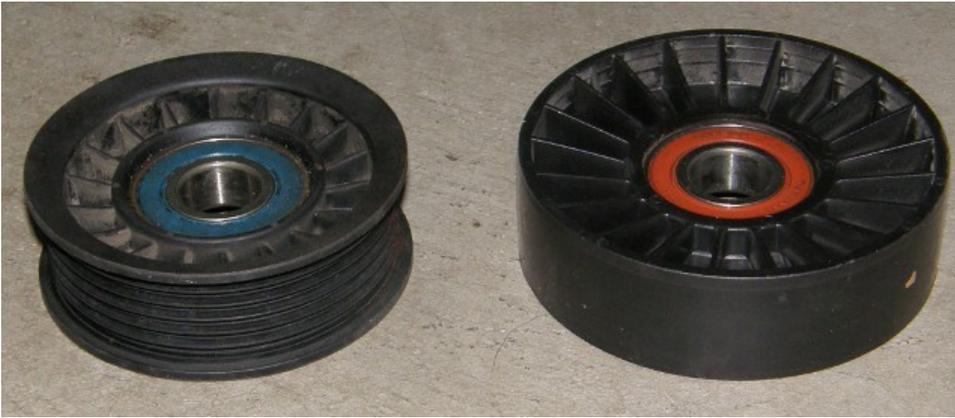
On the left is a ribbed pulley used when you remove the A.I.R pump. On the right is the standard pulley for trucks with A.I.R. It is not completely necessary to swap pulleys. The standard pulley will still properly tension the belt.

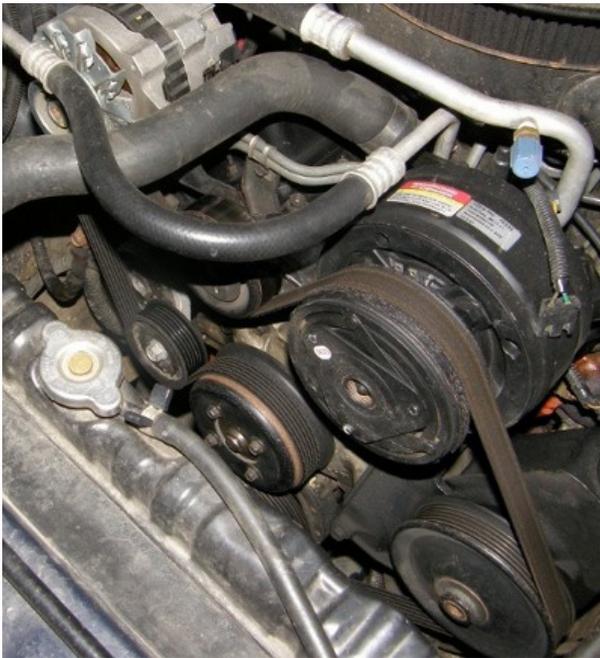
On the left is a setup with A/C on the right is a system without. If you order a belt from a 1991 rodeo with a 3.1L V6 you will get the correct belt. Just make sure you specify if your truck has A/C or not.
